Night IFR Approach in IMC Claims IFR-Rated Private Pilot and Passenger

The following article is based on TSB Final Report A11O0239—Loss of Control—Collision with Terrain. This accident in Ottawa, Ont., took the lives of two local pilots and received a lot of media attention. The TSB report is a very compelling read for all of us, but particularly for IFR-rated private pilots or soon-to-be IFR-rated private pilots.

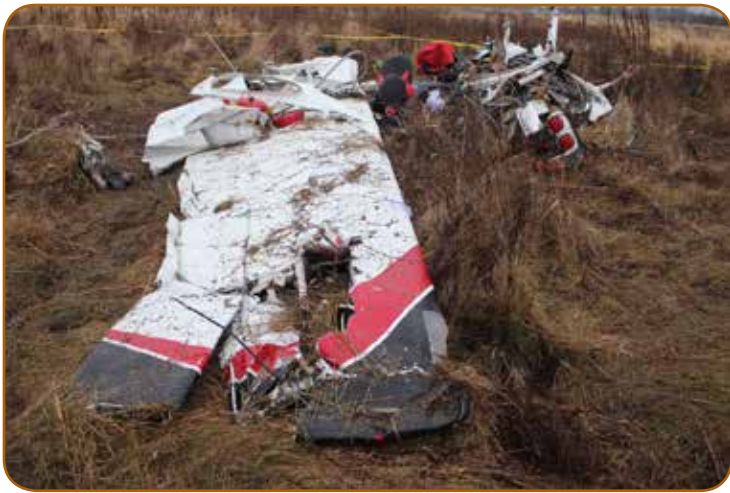
Wreckage of Cessna Cardinal 1.9 NM west of the threshold of Runway 07 at CYOW

At approximately 19:12, the aircraft entered a steep right turn with a rapid descent, and struck power lines before impacting the ground 1.9 NM west of the threshold of Runway 07. Radar data show that, while on the approach, the aircraft twice deviated

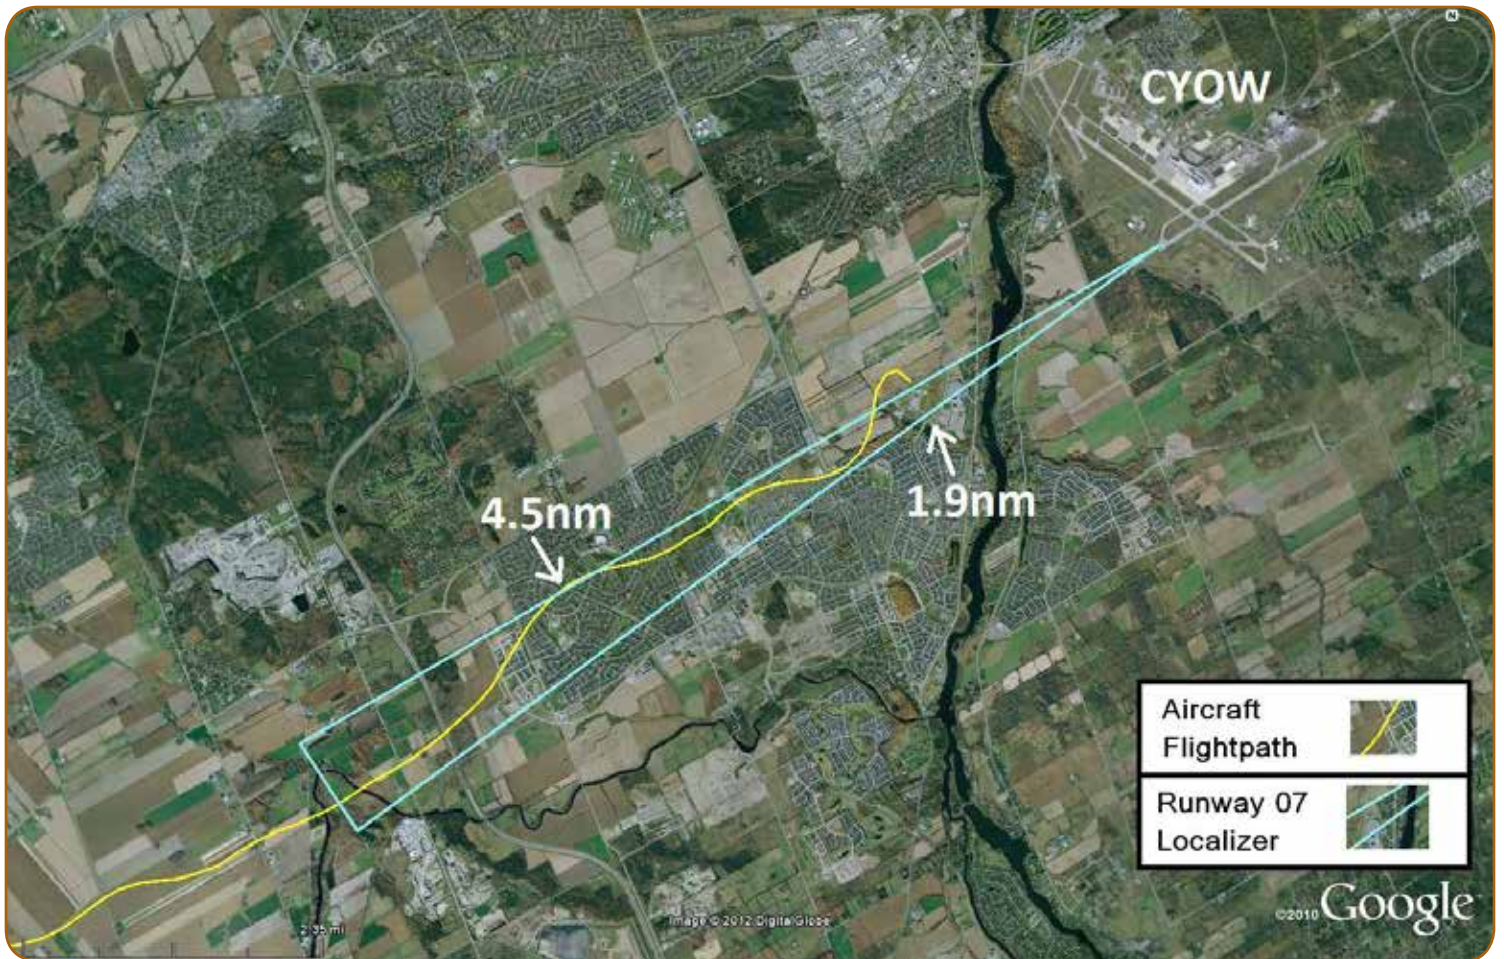
Figure 1—Aircraft's flight path showing its deviations from the localizer during the final approach.

significantly from the localizer to a point that would have caused the localizer indications on the aircraft instruments to go to full deflection. Airspeed on the approach was maintained above 100 kt until the loss of control (Figure 1).

While on the ILS approach into Ottawa in unfamiliar night IMC, the pilot had significant difficulty maintaining the localizer. During the approach, the tower controller twice advised the pilot that the aircraft was deviating from the approach course. During the second attempt to regain the localizer, the pilot most likely made a steep right turn, which quickly developed into a rapid descent and loss of control.
